UNITED STATES ENVIRONMENTAL PROTECTION AGENCY

SUBJ: RCRA Compliance Evaluation Inspection Montco Research Products EPA I.D. Number FLD 061 897 054

RCRA Compliance Inspection Report

Montco Research Products (MRP) 209 Janice Drive Hollister, Florida 32147

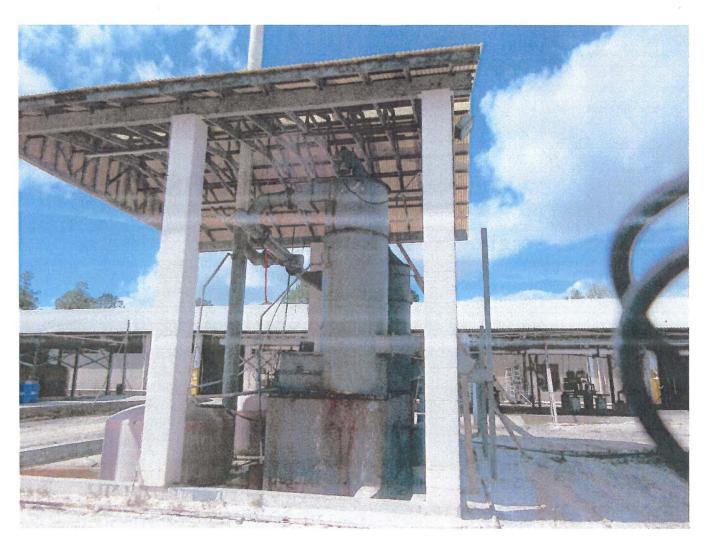
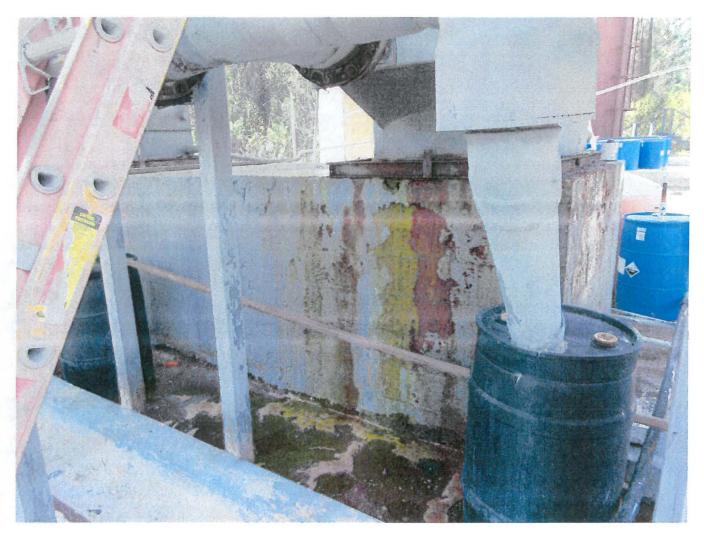
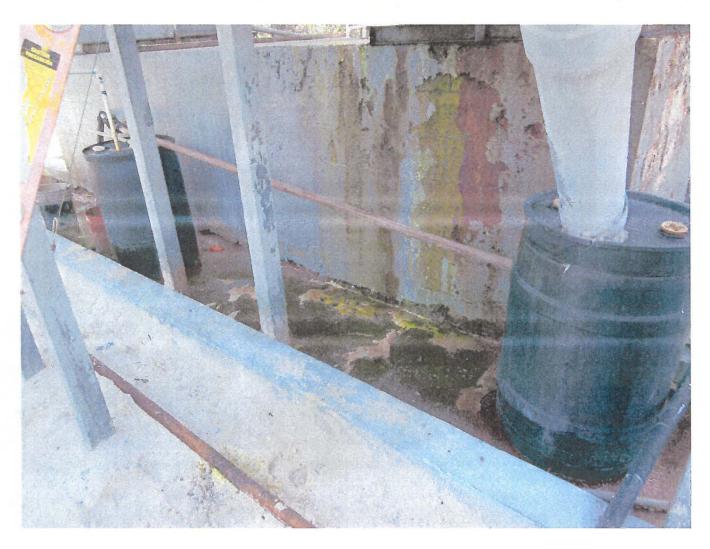
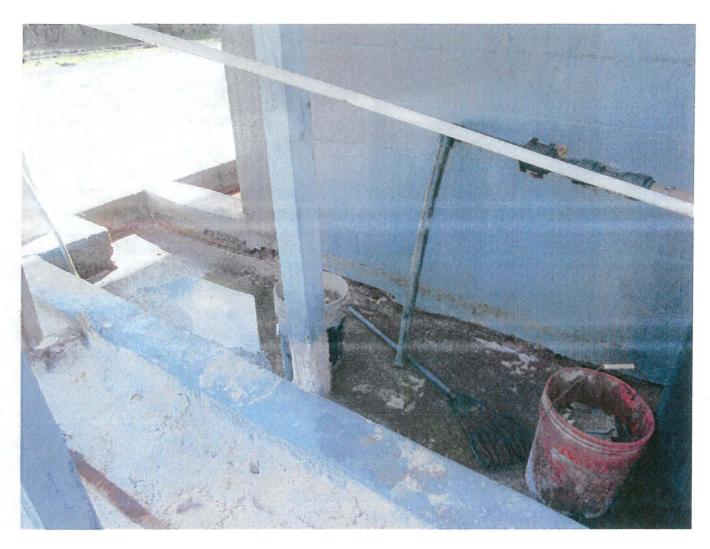
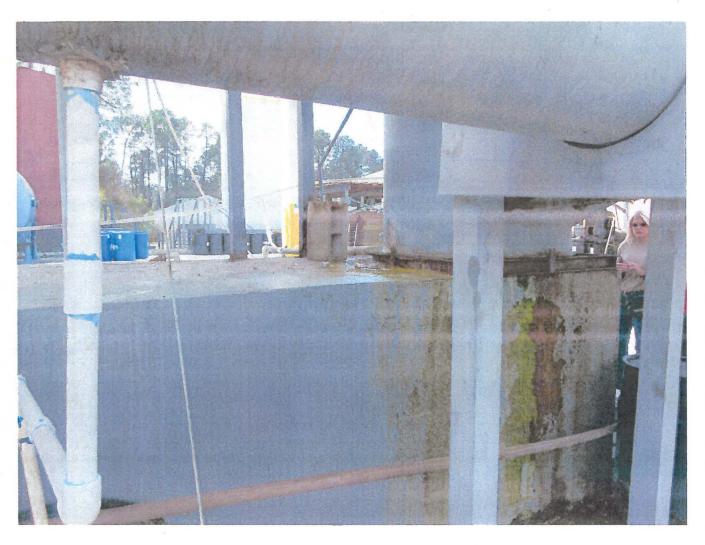
Caustic soda is used by the facility to neutralize acidic vapors captured by the facility's air scrubber system. At the time of the inspection, a liquid having a pH of less than 2 (using pH paper as an indicator) was observed (Photos 1-5) to be leaking onto the concrete support system and within the concrete secondary containment system for the scrubbers.

MRP appeared to be in violation of 40 C.F.R. § 262.34(a)(4) which requires a facility to comply with 40 C.F.R. § 265.31 by maintaining and operating its facility in a way that minimizes the possibility of a fire, explosion, or any unplanned sudden or non-sudden release of hazardous waste or hazardous waste constituents to air, soil, or surface water which could threaten human health or the environment.

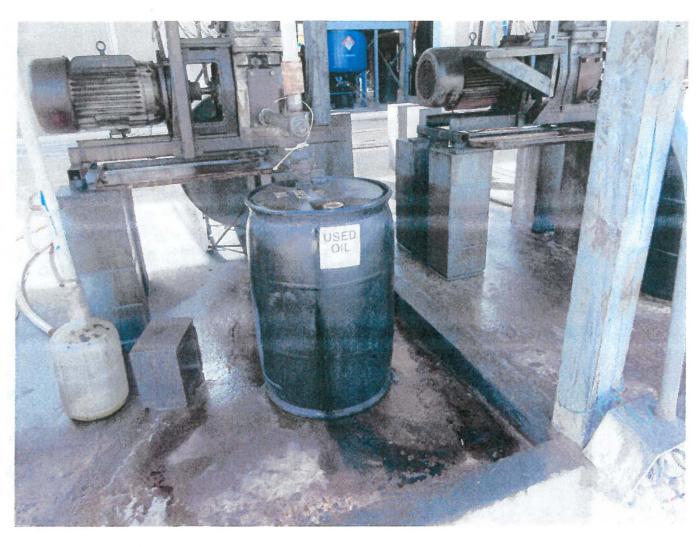
Photo 6 – Vacuum Pump Area near Scrubber Area

A vacuum pump operating near this area was observed to be leaking oil into a secondary containment area at the time of the inspection (Photo 6).

MRP appeared to be in violation of 40 C.F.R. § 279.22(d) by failing to respond to a release of used oil to the environment in accordance with 40 C.F.R. § 279.22(d).

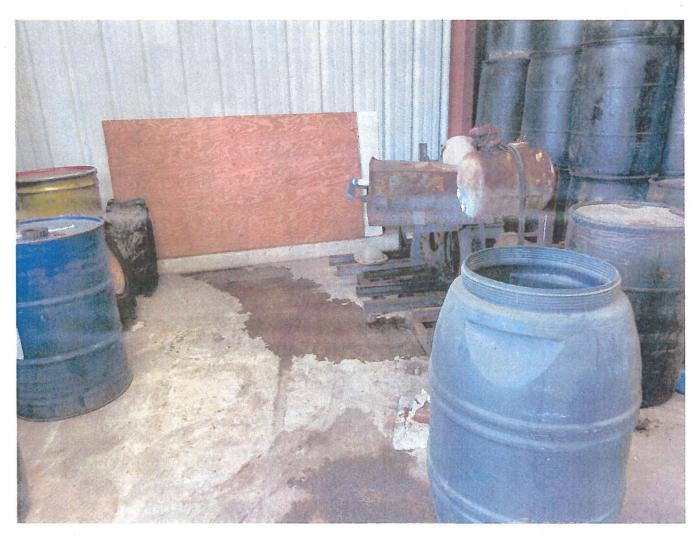
This area contained out of service equipment, raw material containers, and empty drums. At the time of the inspection, an oil spill emanating from an out-of-service vacuum pump was observed (Photo 7).

MRP appeared to be in violation of 40 C.F.R. § 279.22(d) by failing to respond to a release of used oil to the environment in accordance with 40 C.F.R. § 279.22(d).

Photo 7 – Oil Spill from vacuum pump in Drum Storage Area

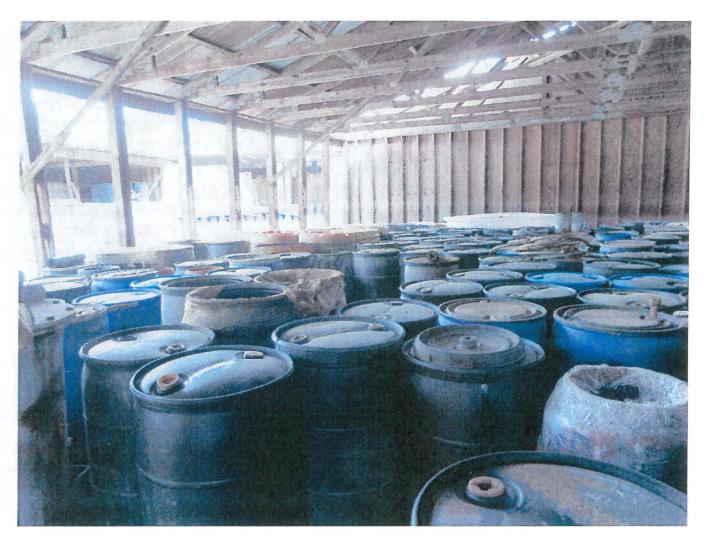
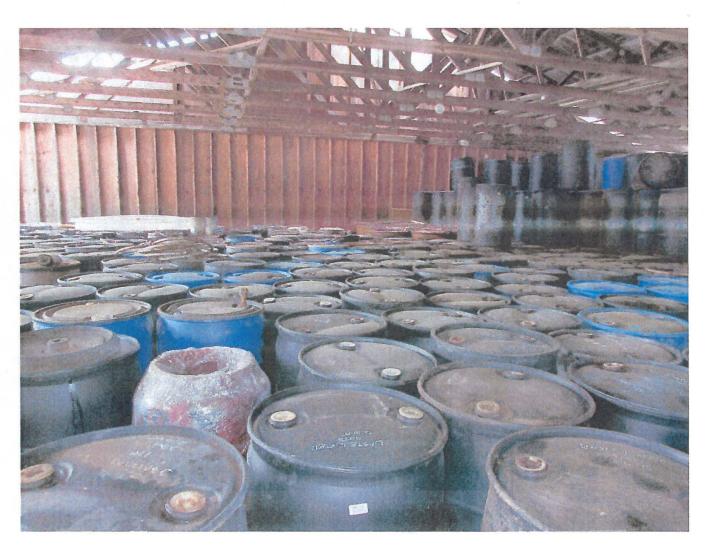
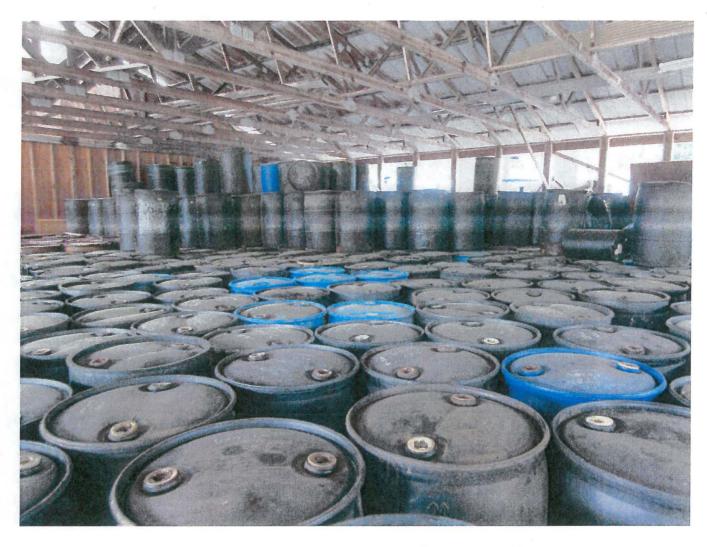
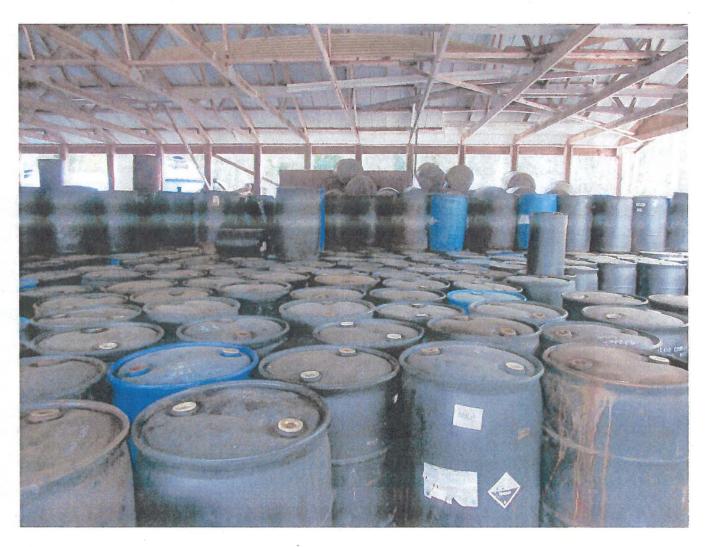
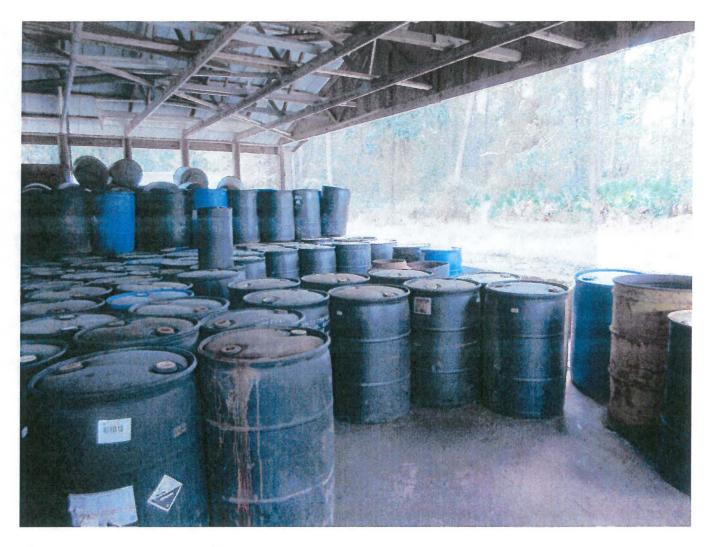
This area contained in excess of 300 55-gallon containers (Photos 8-12). From what could be observed, as there was insufficient aisle space to look at individual labeling on all of the containers. Labeling on some of the containers indicated the presence of distilled HCl, dirty EBC and waste oil (Photos 13 and 14). Numerous containers around the perimeter of the area were empty. Terry Clayton, the facility representative, indicated that containers of material in this area, other than the used oil, were able to be reclaimed in the facility's manufacturing process. Dates on the containers were not visible, in part due to a lack of aisle space, to determine whether the materials destined for reclamation had exceeded time limits allowed pursuant to speculative accumulation.

MRP appeared to be in violation of 40 C.F.R. § 262.11 by failing to make a hazardous waste determination on the containers in this area. As a response to the report, MRP should provide the EPA with the waste determination for the containers described above.

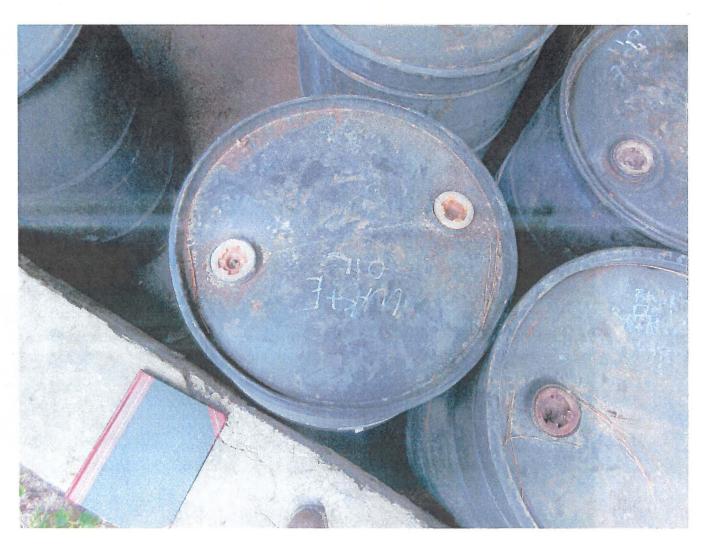
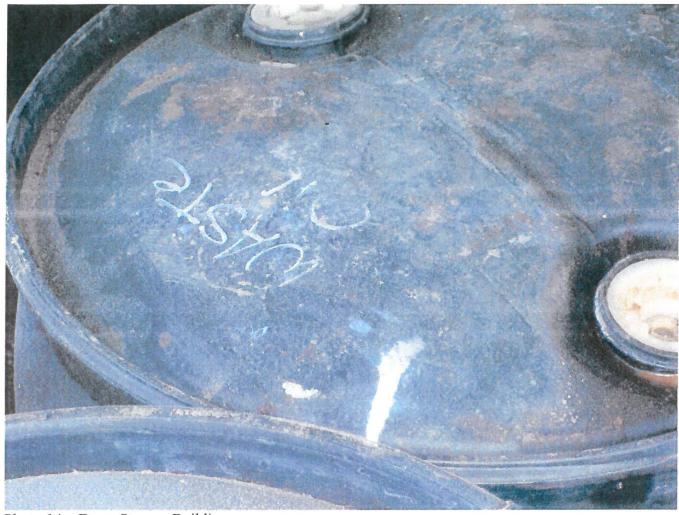
Also, MRP appeared to be in violation of 40 C.F.R. § 279.22(c) by failing to label each of its containers with the words "Used Oil."
